**ROOF EVALUATION
POLICE DEPARTMENT
59 MAIN STREET
PEPPERELL, MA 01463
GALE JN 834720**

INTRODUCTION

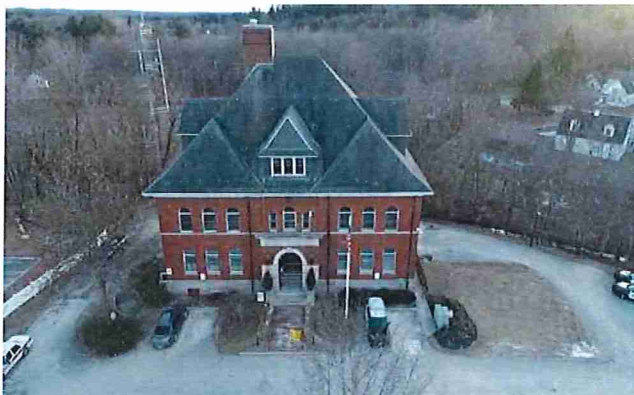
Figure 1: Drone image of the front of the Police Department roof, which consists of asphalt shingles.

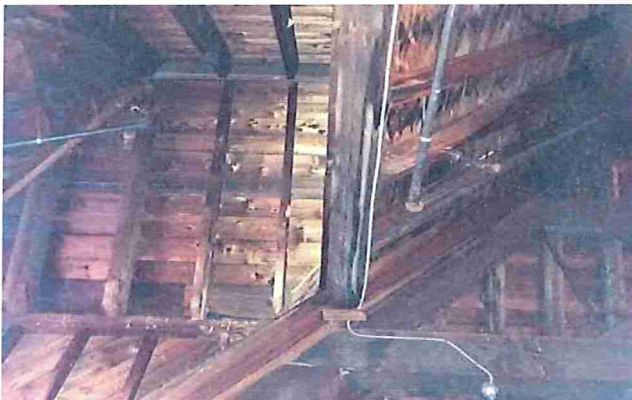
Figure 2: Water staining was noted on the underside of the wood-plank deck and on wood beams at the dormer on the west end, south side of the building.

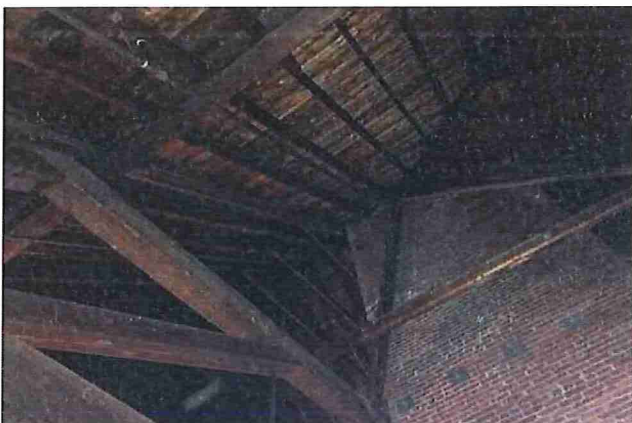
Figure 3: Water staining on the underside of the wood-plank deck and on roof rafters on the south side of the roof near the chimney.

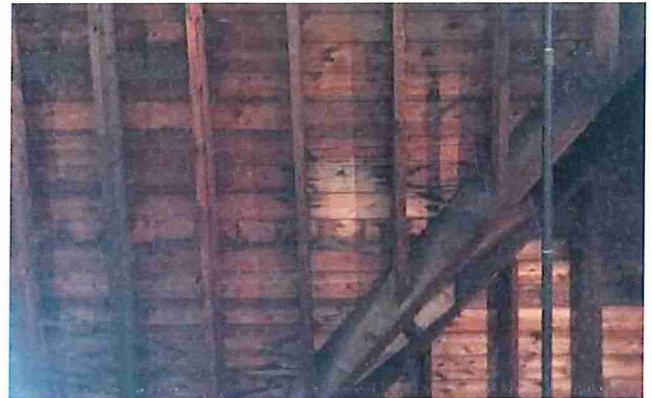
Figure 4: Water staining on the underside of the wood-plank deck and wood rafters at the roof valley.

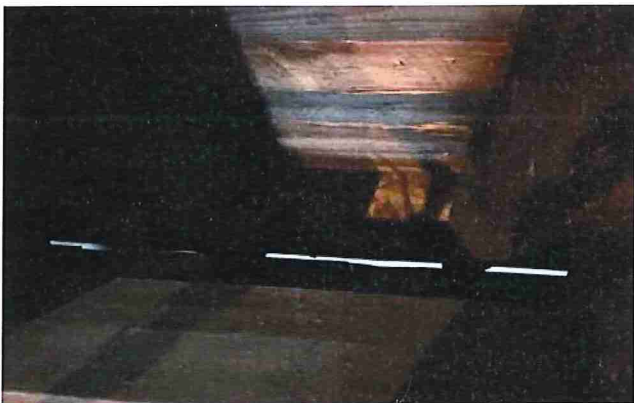
Figure 5: Photo from the building interior shows visible daylight at the roof edge beyond the wall plane. This condition provides ventilation to the attic.

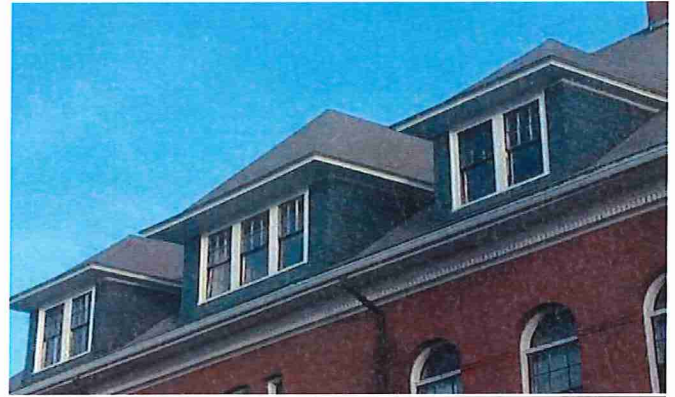
Figure 6: Dormers facades and cheek walls are clad with slate. Wood windows and painted trim accent the facades.

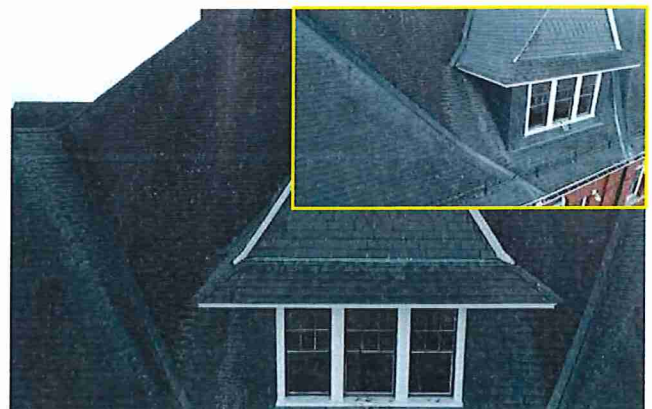
Figure 8: Drone image of the upper north side of the roof where widespread deterioration of asphalt shingles is noted.

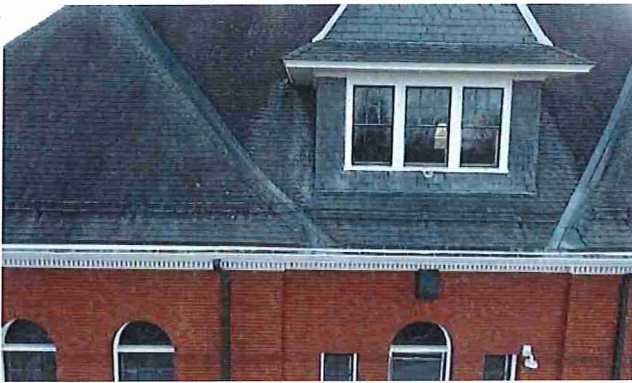
Figure 9: Drone image of the lower north side of the roof where widespread deterioration of asphalt shingles is noted.

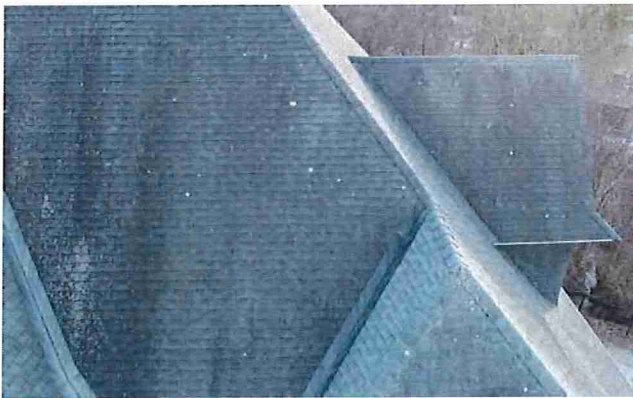
Figure 10: Drone image of the east end, north side, of the roof where widespread deterioration of asphalt shingles is noted.

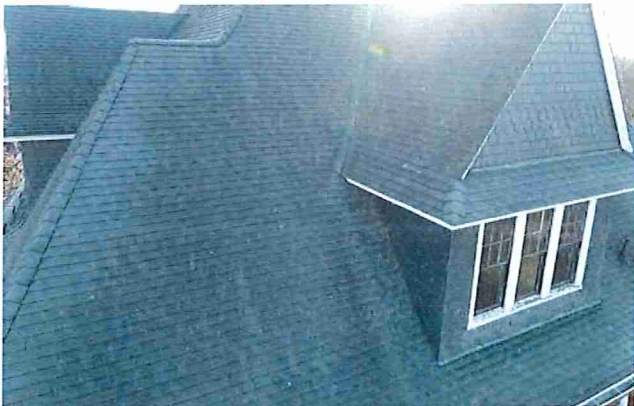
Figure 11: Drone image shows deterioration of shingles on the west side roof.

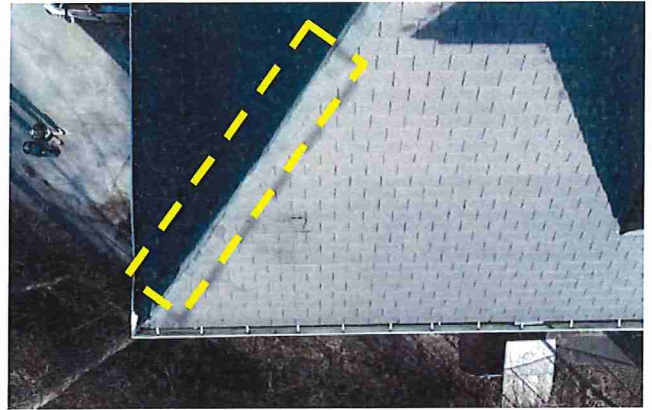
Figure 12: Drone image shows deterioration of shingles on the southwest hip of the roof (dashed outline).

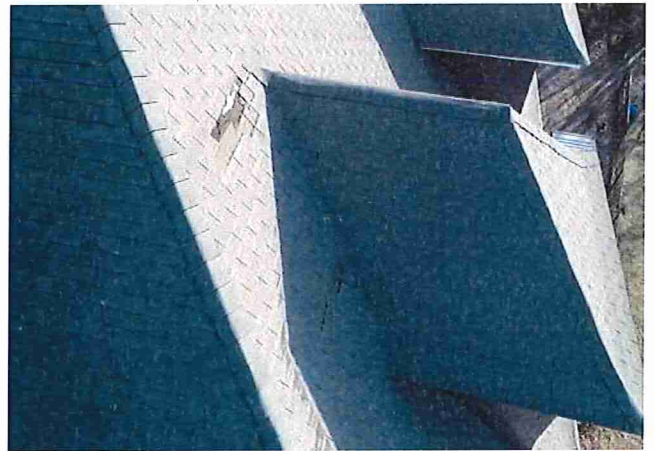
Figure 13: Drone image shows damaged and missing asphalt shingles adjacent to the southwest dormer. The damage closer to the ridge is in the proximity of the reported moisture infiltration below (figure 2).

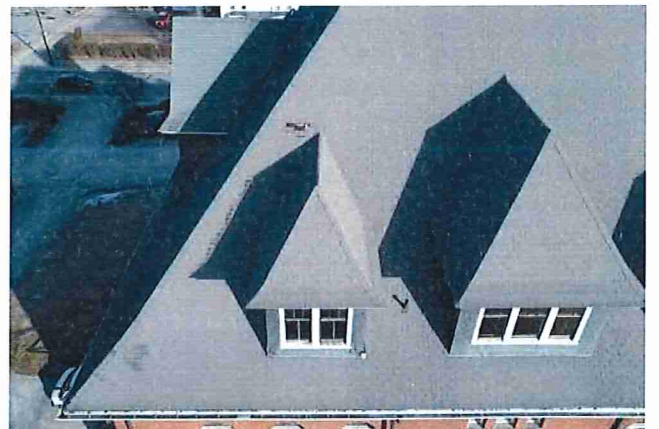
Figure 14: Drone image shows an overview of the conditions referenced in figures 11 and 12.

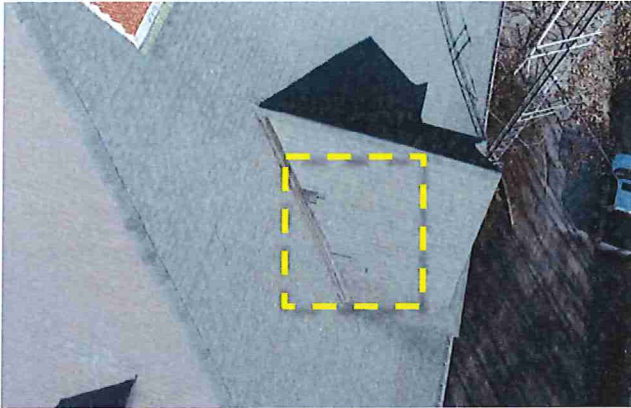
Figure 15: Drone image shows damaged and displaced asphalt shingles on the east dormer roof.

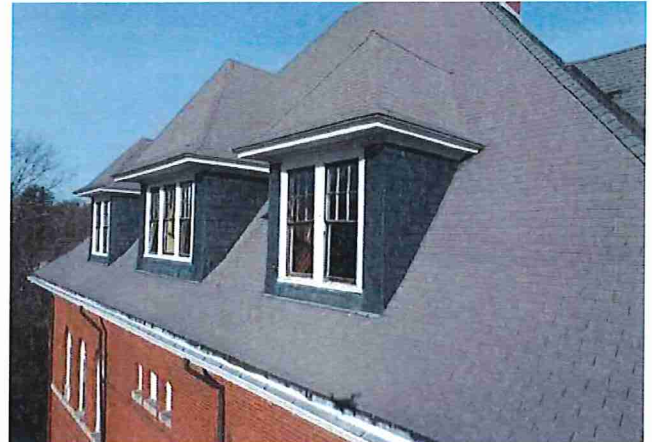
Figure 18: Drone image shows the gutter on the south edge of the roof. The gutter appears clear of debris and obstructions to the downspouts.

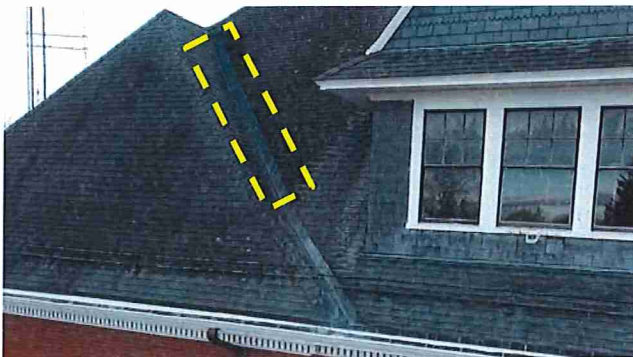
Figure 16: Drone image shows the copper valley flashing above the reported leak area at the northeast corner of the building. The flashing appears to have open seams, one that appears reverse-lapped (dashed outline) that could allow moisture to bypass the roof system.

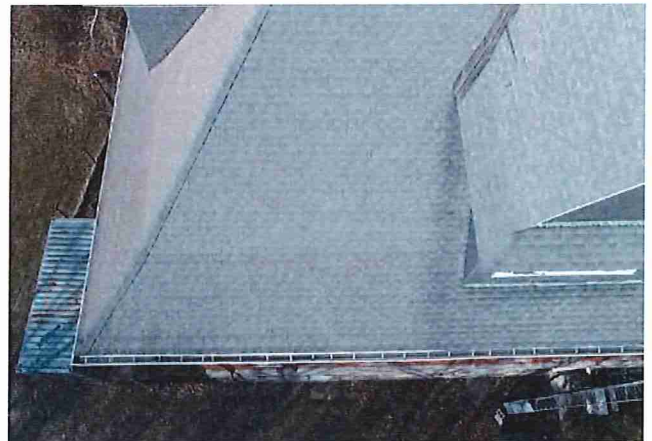
Figure 19: Drone image of the east side roof and gutter. The asphalt shingles exhibit scattered deterioration. The gutter appears clear of debris and obstructions to the downspouts.

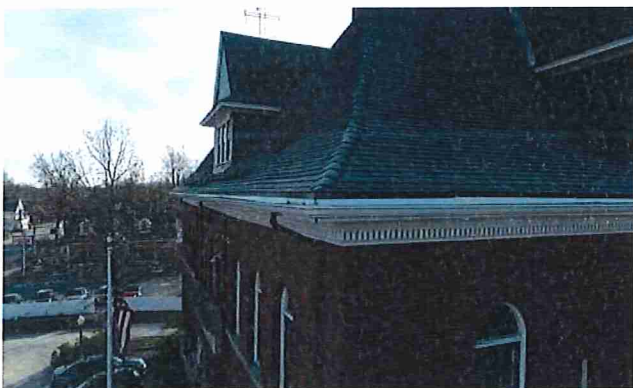
Figure 17: Drone image shows the aluminum gutter on the north and west edges of the roof exhibit some deflection. The gutter flange appears loose on the north edge of the roof. The gutter generally appears clear of debris and obstructions to the downspouts.

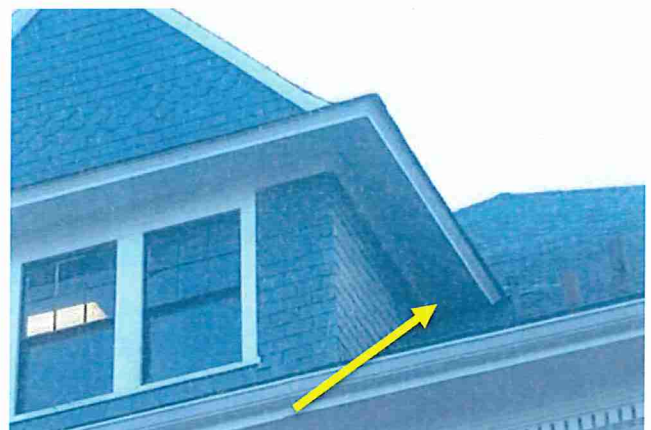
Figure 20: Deteriorated wood trim (arrow) noted on the soffit of the west-side dormer.

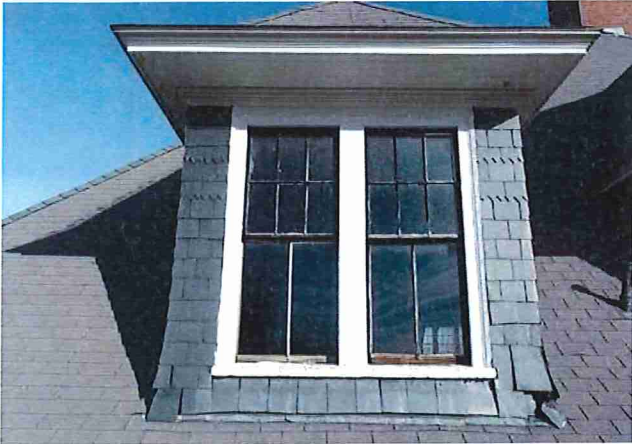
Figure 21: Closeup photo of a dormer façade shows loose, damaged and missing slate. Wood window sashes are deteriorated. Peeling paint is noted on wood trim.

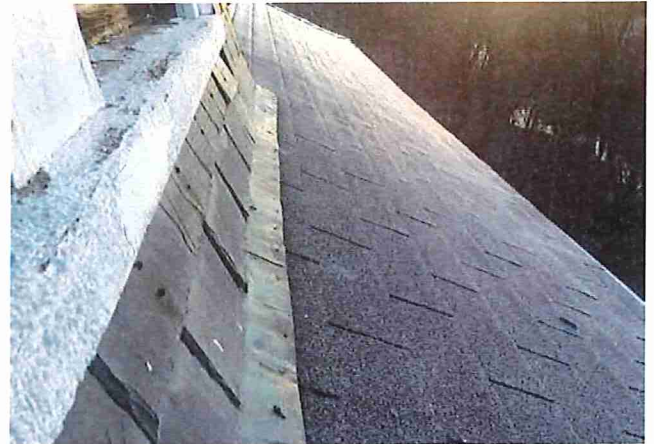
Figure 24: Closeup photo from inside a dormer shows slate nails are generally rusted and loose (backing out).

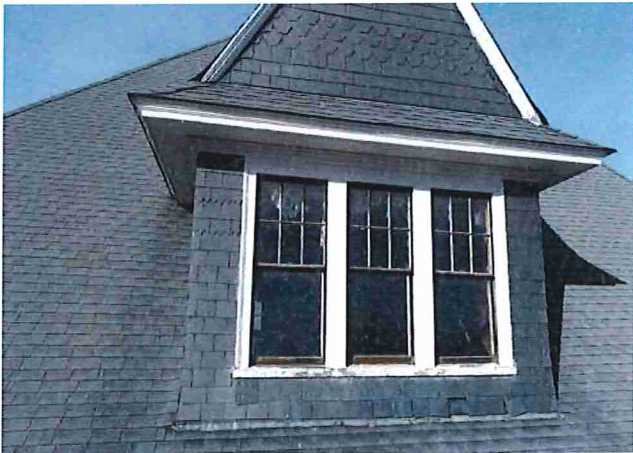
Figure 22: Closeup photo of a dormer façade shows loose and missing slate. Wood window sashes are deteriorated. Peeling paint is noted on wood trim.

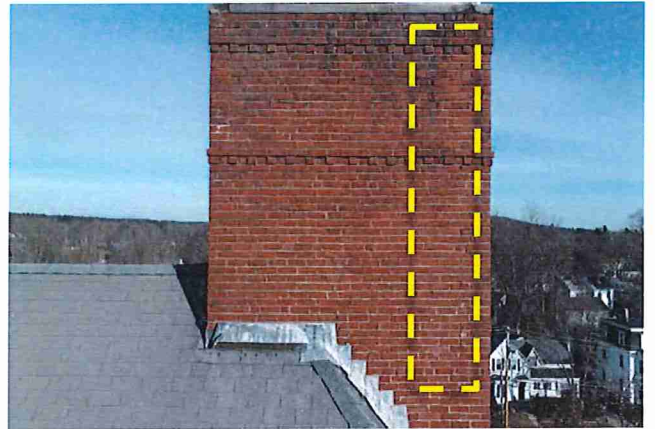
Figure 25: Drone image shows deteriorated mortar joints and step cracking (dashed outline) on the south side of the chimney. The metal flashing, which appears to be lead, at the chimney base is torn open, allowing moisture to bypass the flashing and migrate to the underside of the shingles, and building interior.

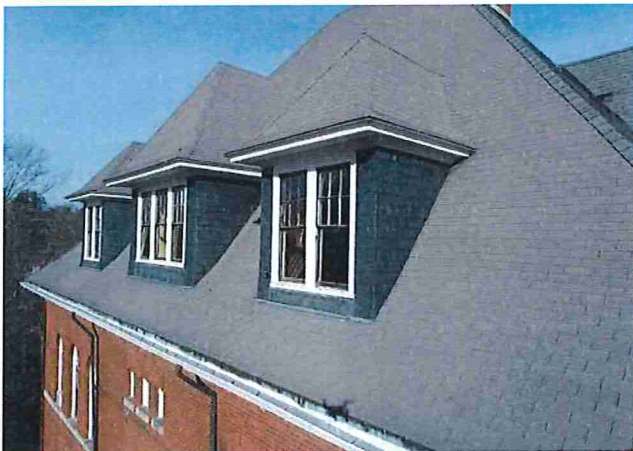
Figure 23: Angled drone image shows loose, damaged and missing slate on the cheek walls as well as on the facades.

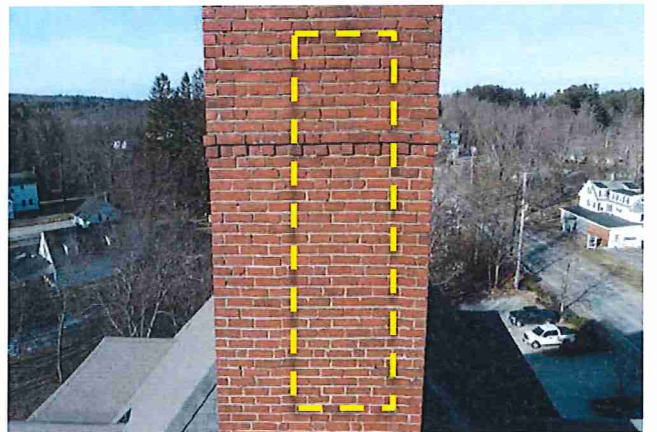
Figure 26: Drone image shows deteriorated mortar joints and step cracking (dashed outline) on the east side of the chimney.

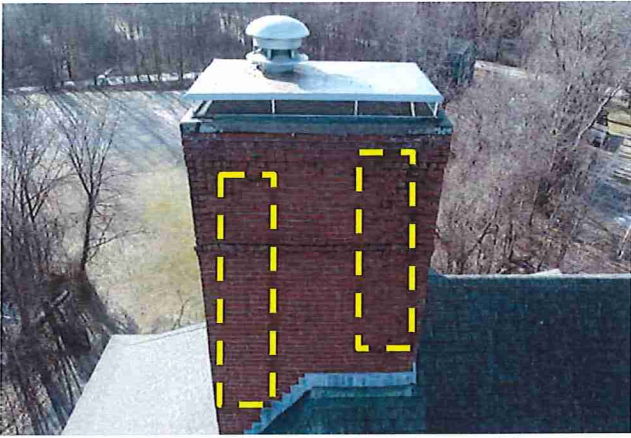
Figure 27: Drone image shows deteriorated mortar joints and step cracking (dashed outline) on the north side of the chimney. Vegetative growth within the mortar joints indicates the masonry is not drying sufficiently on this elevation.

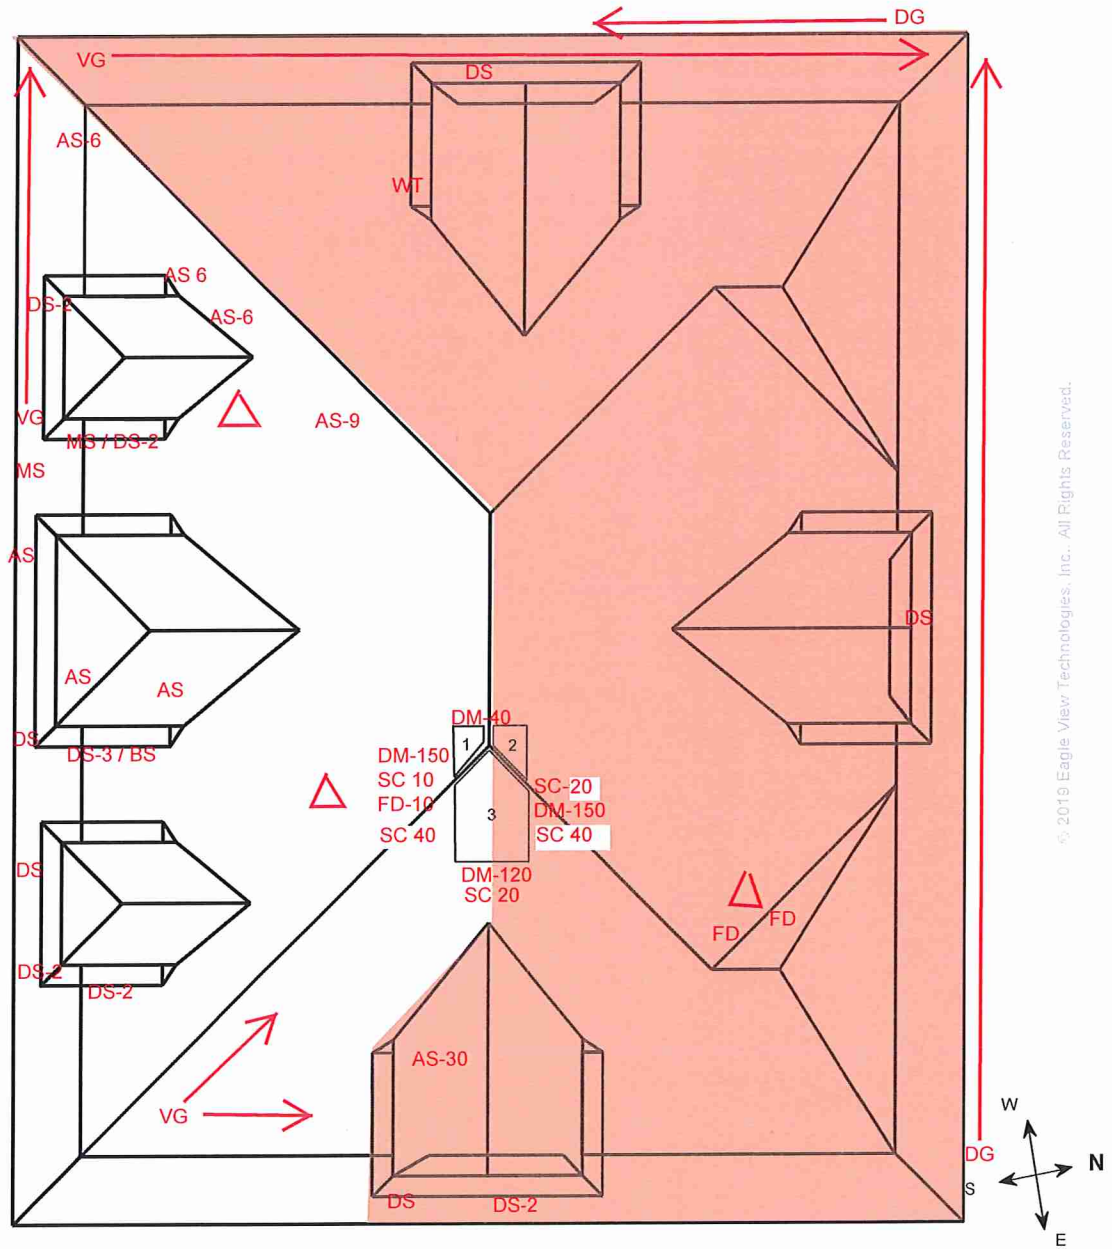
© 2019 Eagle View Technologies, Inc.. All Rights Reserved.
