# INDOOR AIR QUALITY ASSESSMENT

**Pepperell Police Department  
59 Main Street  
Pepperell, MA**

Prepared by:  
Massachusetts Department of Public Health  
Bureau of Environmental Health  
Indoor Air Quality Program  
January 2020

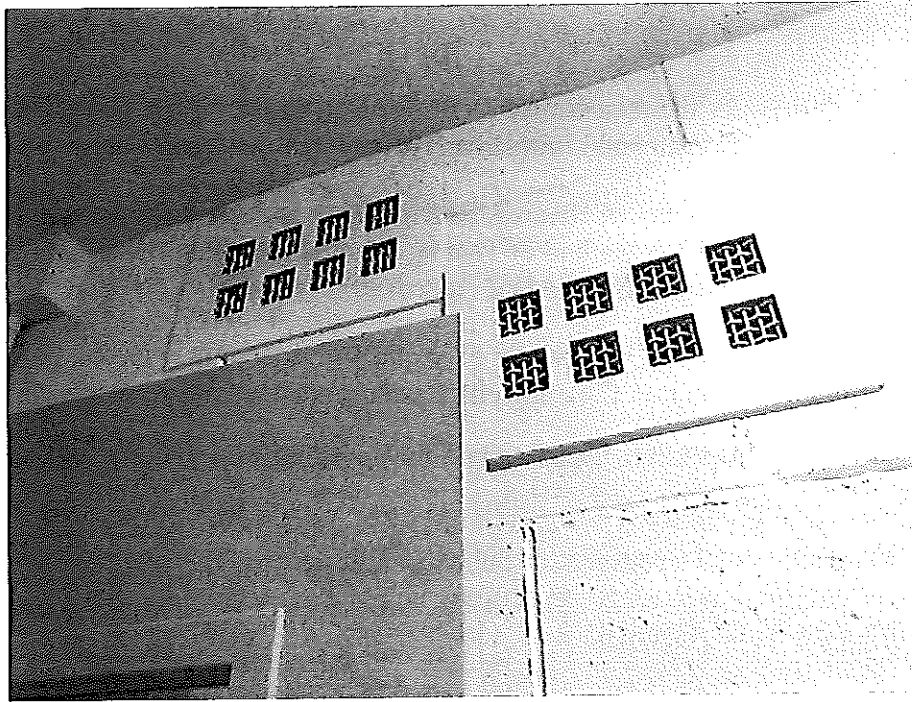
Picture 1

It is important to note, however, that the building does not have a mechanical ventilation system to provide fresh air to the first or second floor. These areas rely on openable windows and incidental air leakage for air exchange. There is a mechanical ventilation system for the basement lock-up area. An air handling unit (AHU) located in the basement area supplies fresh air through ceiling or wall-mounted vents (Picture 1). Return air is ducted back to the AHU.

Supply and return vents in the lockup/lab area

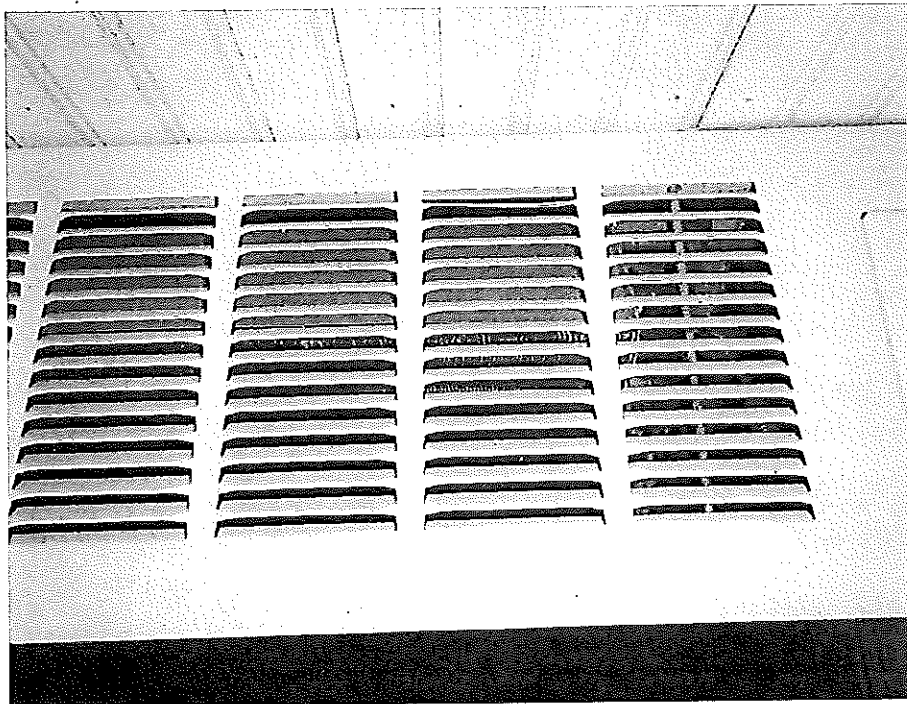
Picture 2

First floor offices are equipped with fan coil units (FCUs). FCUs do not introduce outside air and are limited to recirculating air. FCUs are designed to draw from a return air intake vent located at the base of each unit (Figure 1), to provide heat or cooling. Since the previous visit in 2013, the FCUs for the first floor have been replaced with new units (Picture 2), which appeared to be functional and in good condition.

Top of new fan coil unit

4. Maintain FCUs including changing filters regularly. Store unused filters in a clean dry area until needed.
5. Ensure condensation drainage from FCUs and ductless ACs drain properly without leaks or clogs.

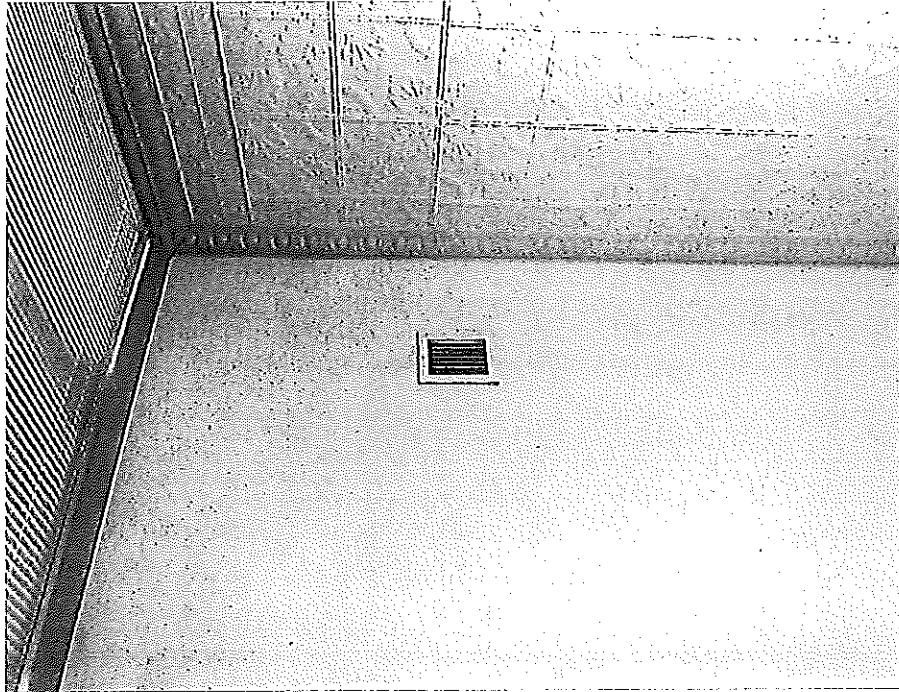
**Picture 3**

First floor offices have mechanical exhaust vents connected to fans in the attic (Picture 3). These vents were drawing air during the assessment. Note that without a source of mechanical fresh air, offices on the first floor are likely to become *depressurized*. Buildings with offices are usually designed to be *pressurized* to prevent the draw of odors from wall cavities or

**Wall-mounted exhaust vent in one of the first-floor offices**

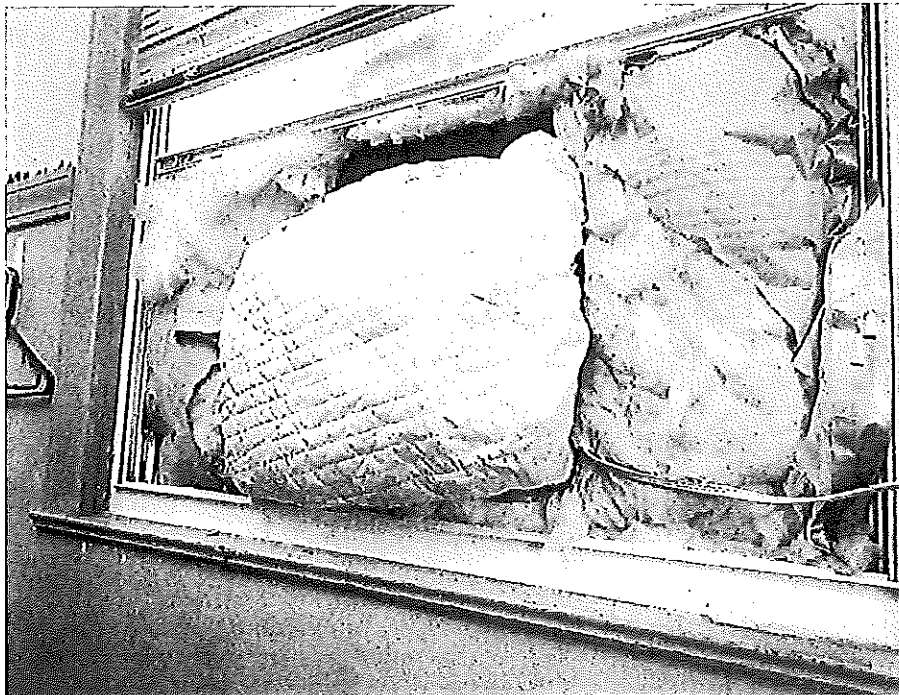
**Picture 4**

Areas on the upper floor had window-mounted air conditioners which can be used to provide some fresh air even without cooling using a “fan only” setting (Picture 4). Wall-mounted ductless air conditioners are also present in a few areas for supplemental cooling (Picture 5).

Other moisture/odor-related issues were found in the PPD. Window air conditioners were found installed with porous items around them (e.g., Picture 4). This material can become moistened and become a source of mold and odors. Also note that the exposed fiberglass insulation shown in Picture 4 can become a source of irritating fibers.

**Window air conditioner with cover for winter, note condition of surrounding insulation**

16. Seal around window ACs using non-porous materials. Remove any uncontained fiberglass to prevent irritating dusts.
17. Ensure water-damaged materials are cleaned, replaced, and/or repaired in a manner consistent with the U.S. Environmental Protection Agency's guidelines (US EPA, 2008).

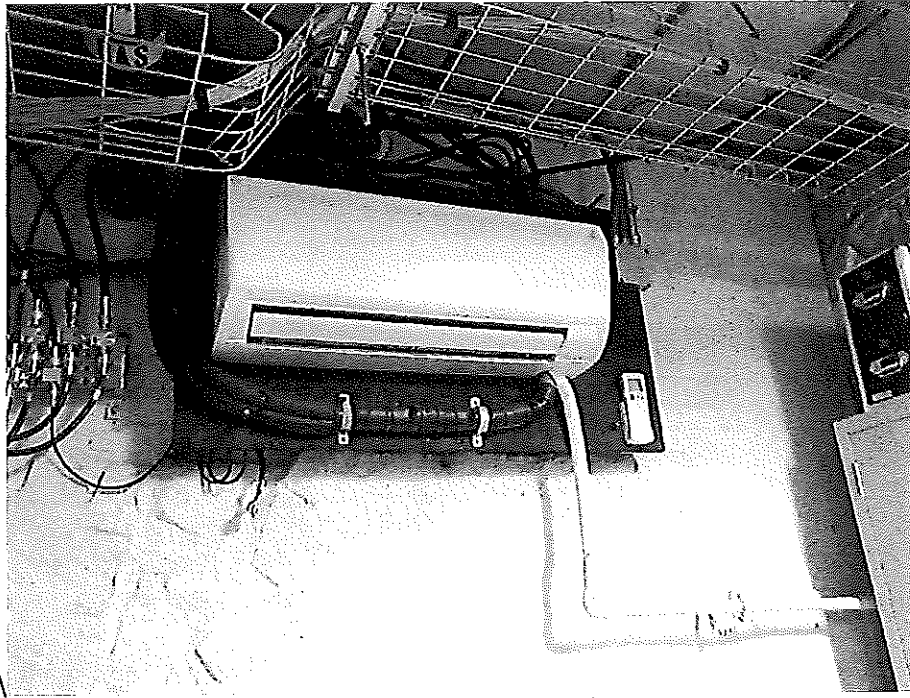
Picture 5

Ductless air conditioner with condensation drain

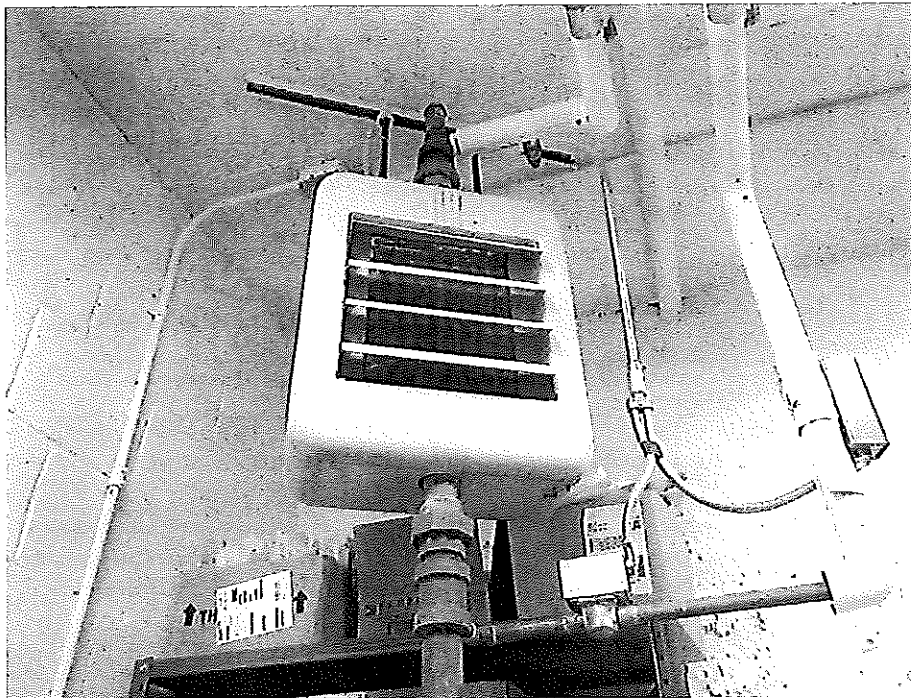
Picture 6

Additional heat for some basement/utility areas is supplied by unit heaters (Picture 6). These units appeared to be hydronic (using hot water or steam). However, if any use combustion (e.g., natural gas), they need to operate in a well-ventilated area and carbon monoxide detectors should be used in each location to prevent exposure to hazardous conditions.

Unit heater, likely hot water operated

8. Ensure carbon monoxide detectors are installed in areas where combustion is taking place, such as the boiler room and where any gas-fired heaters are operating. Ensure they are tested and maintained/replaced in accordance with manufacturer's recommendations.

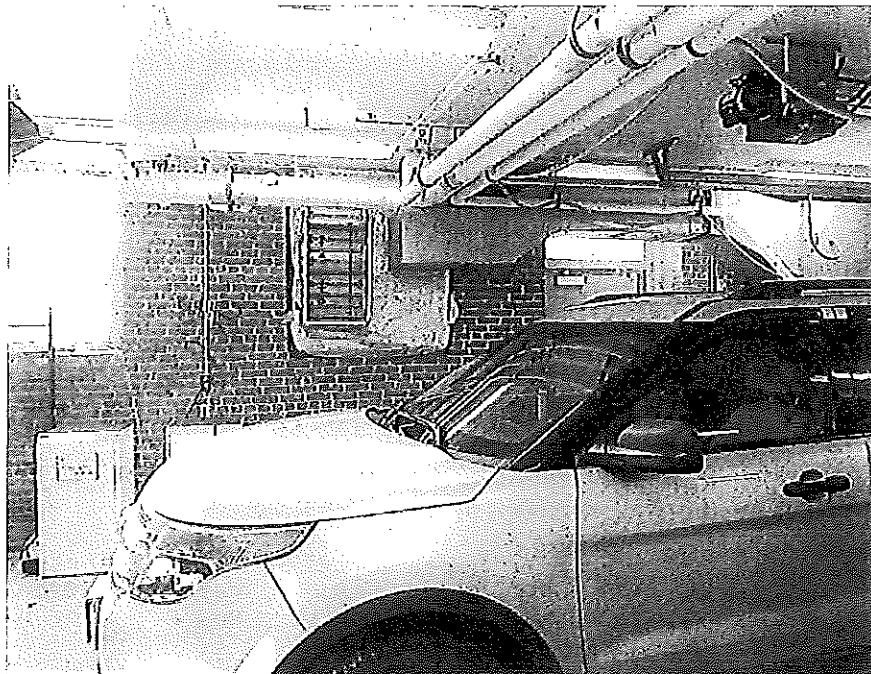
**Picture 7**

The garage area has space for two vehicles. It is equipped with a switch-activated exhaust system which appeared to be functional (Picture 7). This exhaust system should be used whenever vehicles enter the space. Vehicles should not be idled inside the building.

**Automatic make-up air louvers for the garage exhaust system; note exhaust system on the right**

2. Close windows when air conditioning is in use to prevent the introduction of hot humid air into the building that may lead to condensation.
3. When vehicles are brought into the garage, use the exhaust system consistently to remove products of combustion from the building.

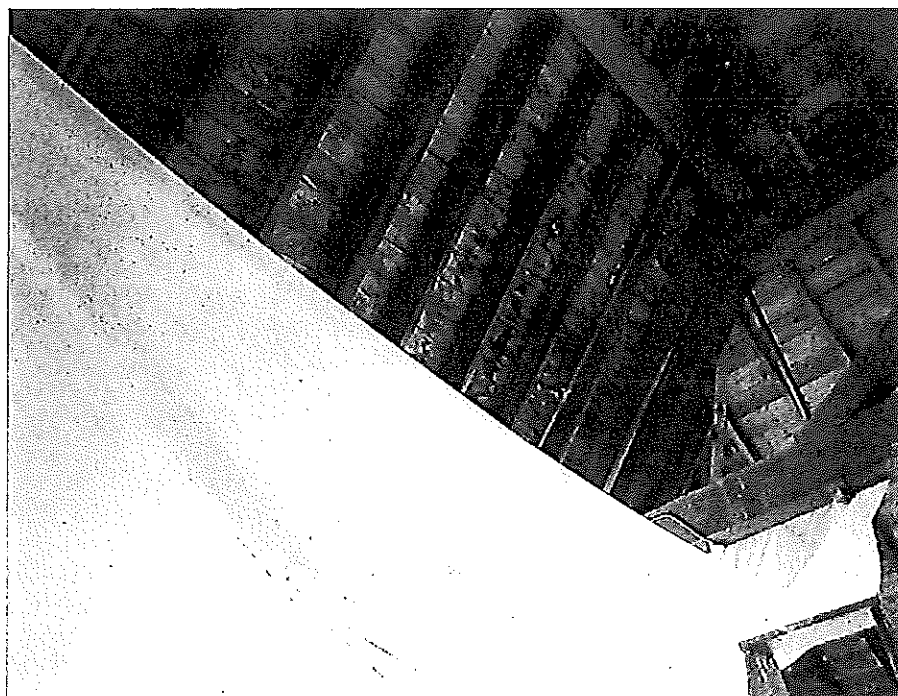
**Picture 8**

Water infiltration and water damage was noted in several areas of the building. Roof leaks have been reported, although some areas of the roof have been repaired recently. In one area of the attic, a plastic tarp and bucket had been constructed to capture water leaks from the roof (Picture 8). Until the roof can be repaired to address the leak, the bucket needs to be emptied out and cleaned regularly to avoid becoming a source of spills and odors.

**Tarp used to collect water from leaking roof**

9. Until roof leaks can be repaired, continue to monitor and empty leak collecting vessels in the attic. Periodically inspect the attic for water infiltration in areas of flashing.

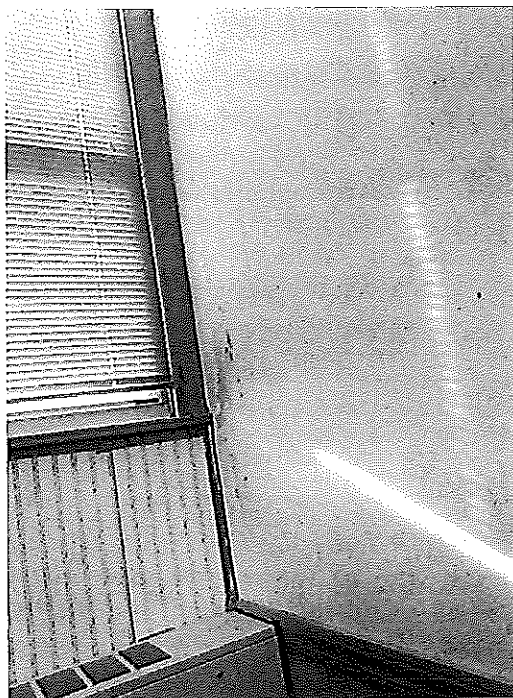
**Picture 9**

Occupants reported that work was conducted to remove water-damaged and moldy materials after the previous assessment. Picture 9 shows an area of wall that had been cleaned/stripped to remove mold. Another wall was found with water stains, reportedly from a historic leak (Picture 10). Water-damaged walls should be cleaned and be refinished following remediation. Other leaks, such as from a urinal, were reported to have occurred in the past.

**Damaged wall where moldy material had reportedly been cleaned/stripped**

18. Repaint/refinish areas of historic or previously-remediated water damage.
19. Scrape and repaint/refinish ceilings to prevent dust and debris. Ensure that lead-safe procedures are used.

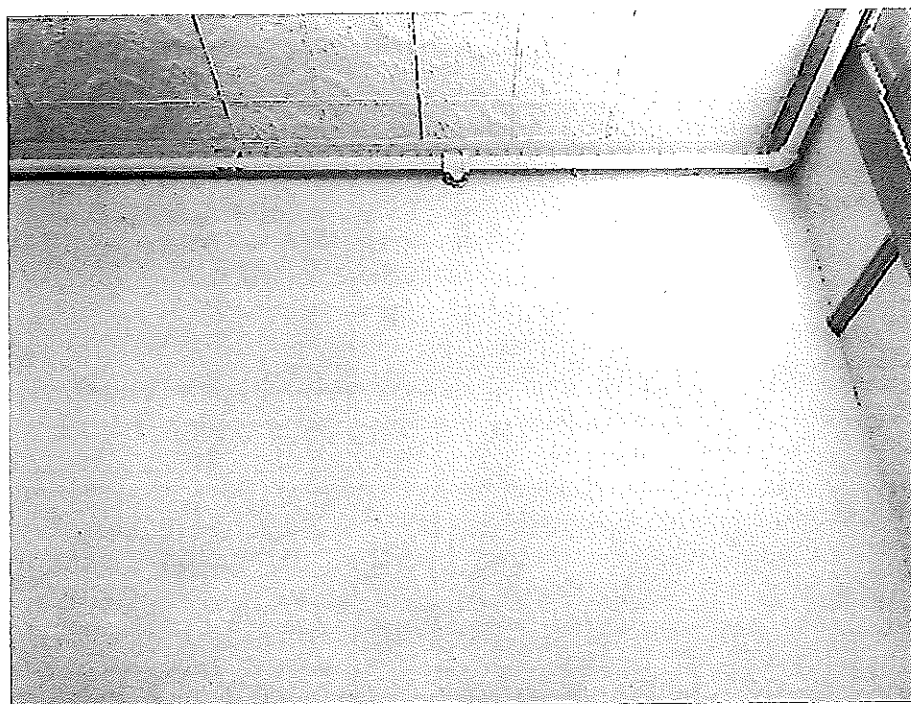
**Picture 10**

**Water-damaged wall**

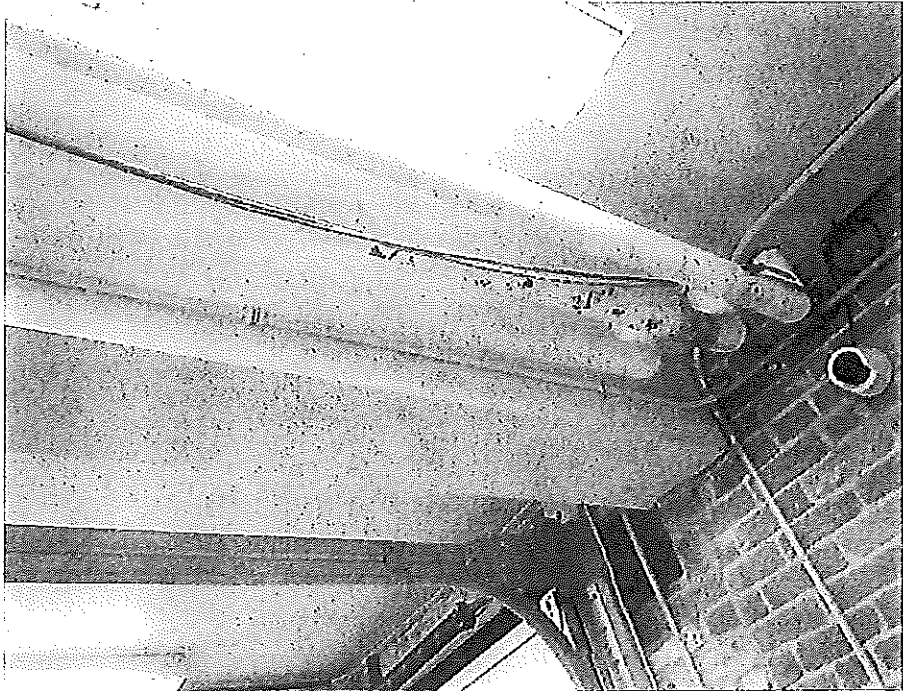
**Picture 11**

Several areas of water damage were observed on the lower level. Moldy items, including pipe wrap and papers, were found in the garage (Pictures 11 through 13). Musty odors were noted in other parts of the lower level. Several factors contribute to water damage, mold, and odors in the garage and other parts of the basement:

Note that the pipe wrap seen in Pictures 11 and 12 replaced other mold-colonized pipe wrap reported in the previous assessment (Appendix A). The construction of this pipe wrap appears to include an outer paper layer which is highly susceptible to mold colonization. Replacement pipe wrap in a damp environment such as this garage should be composed of non-porous, non-carbon-containing materials that are resistant to mold growth.

**Likely mold spots on pipe wrap in the garage**

10. Maintain plumbing to prevent leaks.
11. Remove water-damaged and mold-colonized porous materials from the garage and basement (e.g., pipe wrap, paper, boxes). Replace pipe wrap with a non-porous mold-resistant material.

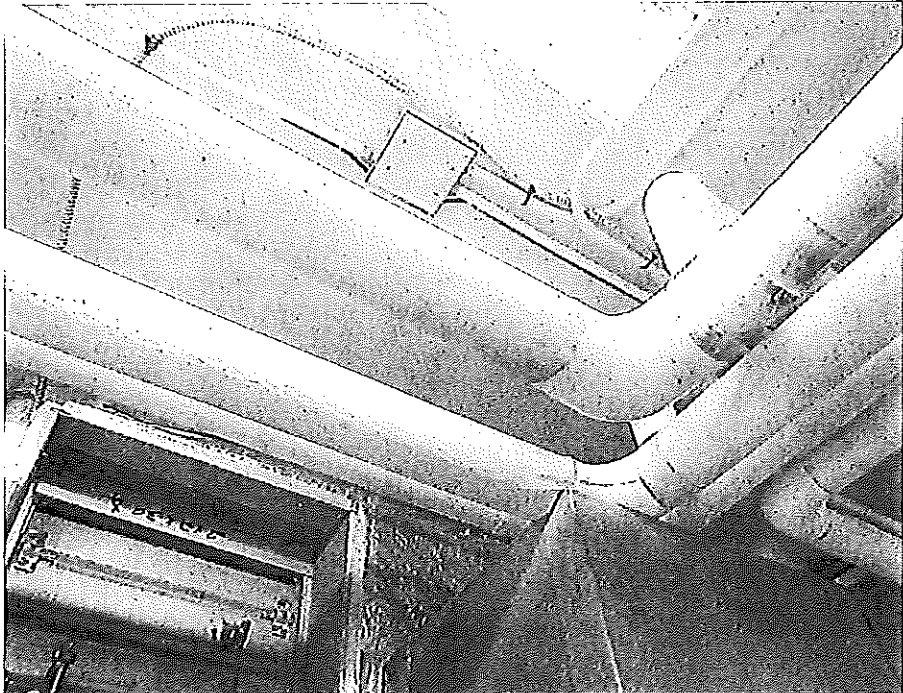
**Picture 12**

**Likely mold spots on pipe wrap in the garage**

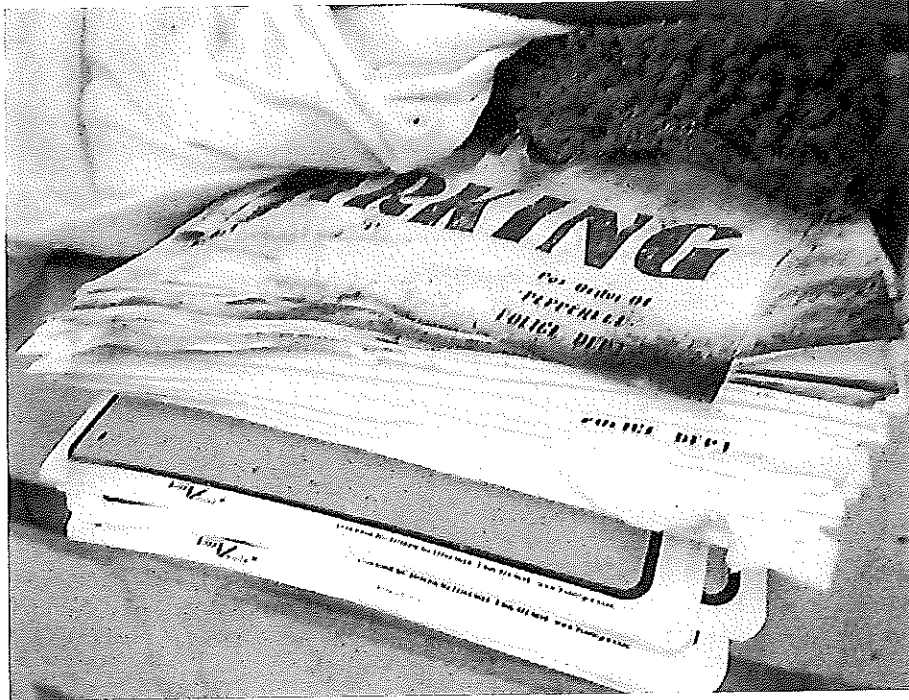
Picture 13

Mold-colonized paper in the garage

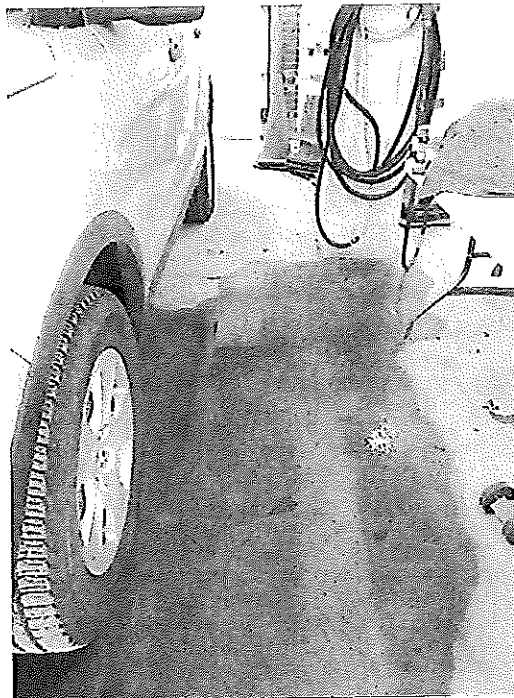
Picture 14

- Open garage doors and cars in the garage bring in rainwater/snowmelt, leading to puddles and increased humidity (Picture 14);

Puddle on garage floor

12. Consider washing cars outside the building or use the services of a commercial car wash.
13. Ensure floor drains in the garage and basement are free-flowing to remove rain, snow melt and drainage from the heating system.

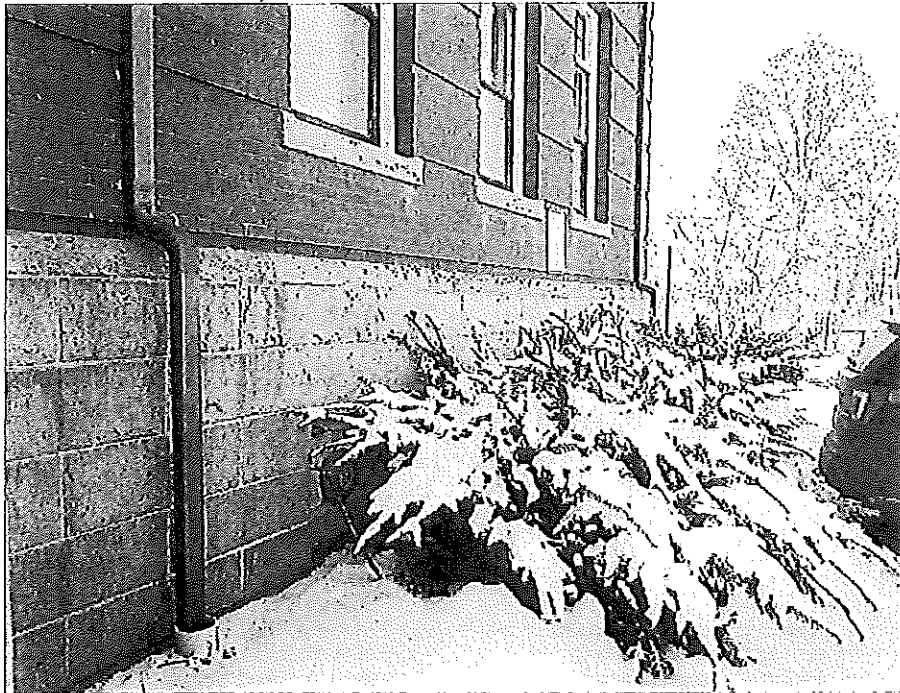
**Picture 16**

- Shrubs and plants against the building hold water against the brick and foundation (Picture 16). This can lead to deterioration of the building envelope and increased water penetration.

**Bushes against the foundation**

14. Remove shrubs from against the building and trim plants at least five feet away from the foundation.
15. Use dehumidifiers in the basement, if possible with current electrical systems. Clean and maintain them regularly to prevent odors.

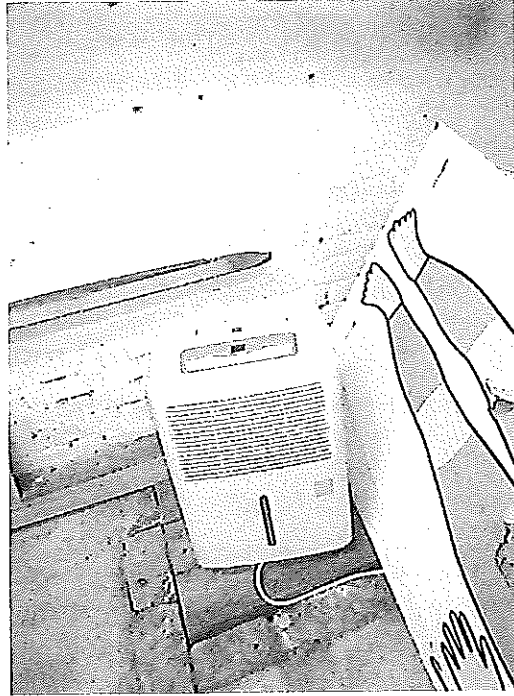
**Picture 17**

Dehumidifiers were placed in the basement (Picture 17), but it was reported that these units cause too much stress on the electrical system of the building to be used. Dehumidifiers can be helpful in reducing humidity-related issues in basement areas. If used, they need to be emptied and cleaned regularly to avoid becoming a source of odors.

**Dehumidifier, likely not plugged in**

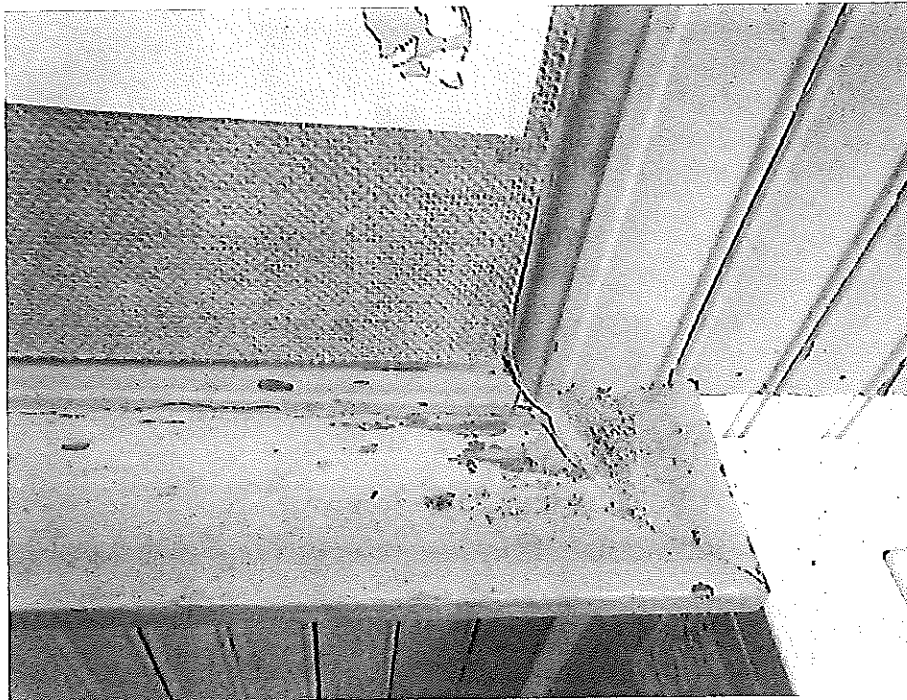
**Picture 18**

Other issues were identified that may contribute to IAQ issues. Dust and debris was found in many areas of the building (Pictures 18-22). One source of this dust and debris is deterioration and wear of building materials such as brick and wood. This material can be irritating if aerosolized and should be cleaned regularly. The attic floor was insulated using a spray foam material (Pictures 19 and 20). This material is exposed between the floorboards and is flaking off creating another source of dust/debris. The condition of this insulation material may indicate the foam was not properly installed and has become prematurely brittle, or it may be due to mechanical wear from it being exposed to foot traffic. The ceiling in the upper level has flaking paint (Picture 23), which also contributes to debris. Based on the age of the building, this paint may contain lead, so appropriate measure should be taken to contain dust and debris from paint scraping work to prevent exposure.

**Brick and wood dust**

22. Regularly clean dust and debris from surfaces in the building. Flag areas with significant accumulations of dust/debris to check for potential pests (e.g., carpenter ants or termites), and for future repairs/replacement of wood and masonry.

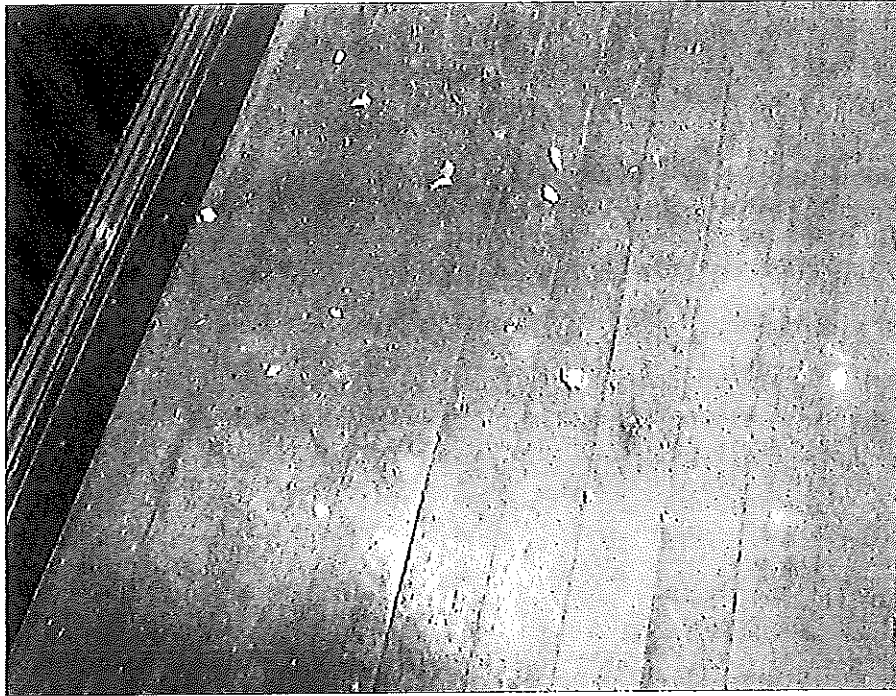
**Picture 19**

**Dust and debris, including debris from foam insulation of attic floor**

23. Consider covering areas of the attic with walkways to minimize abrasion/deterioration of insulation foam.
24. For buildings in New England, periods of low relative humidity during the winter are often unavoidable. Therefore, scrupulous cleaning practices should be adopted to minimize common indoor air contaminants whose irritant effects can be enhanced when the relative humidity is low. To control for dusts, a high efficiency particulate arrestance (HEPA) filter equipped vacuum cleaner in conjunction with wet wiping of all surfaces is recommended. Avoid the use of feather dusters. Drinking water during the day can help ease some symptoms associated with a dry environment (throat and sinus irritations).

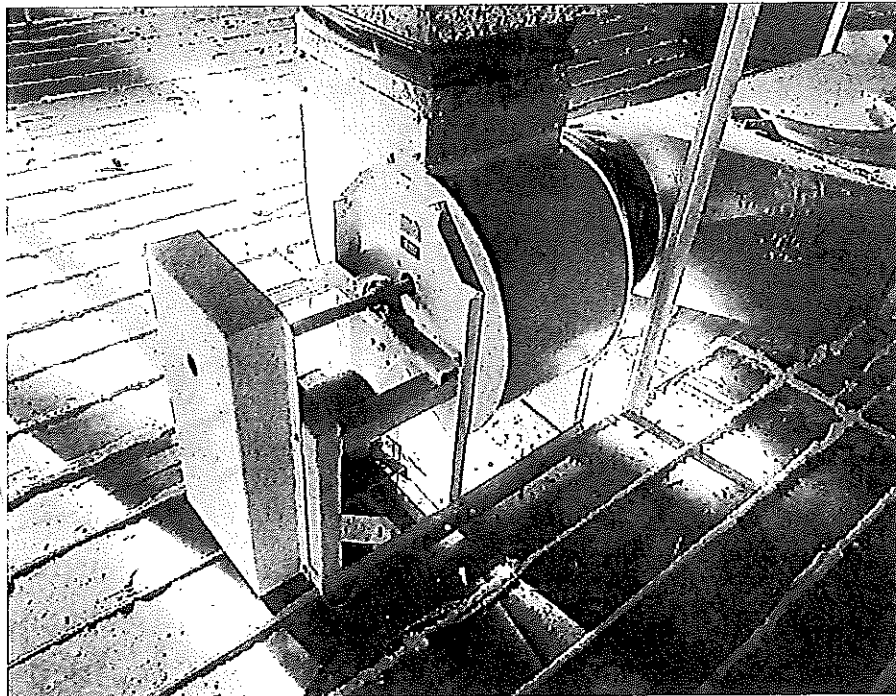
**Picture 20**

**Debris and foam insulation on the attic floor**

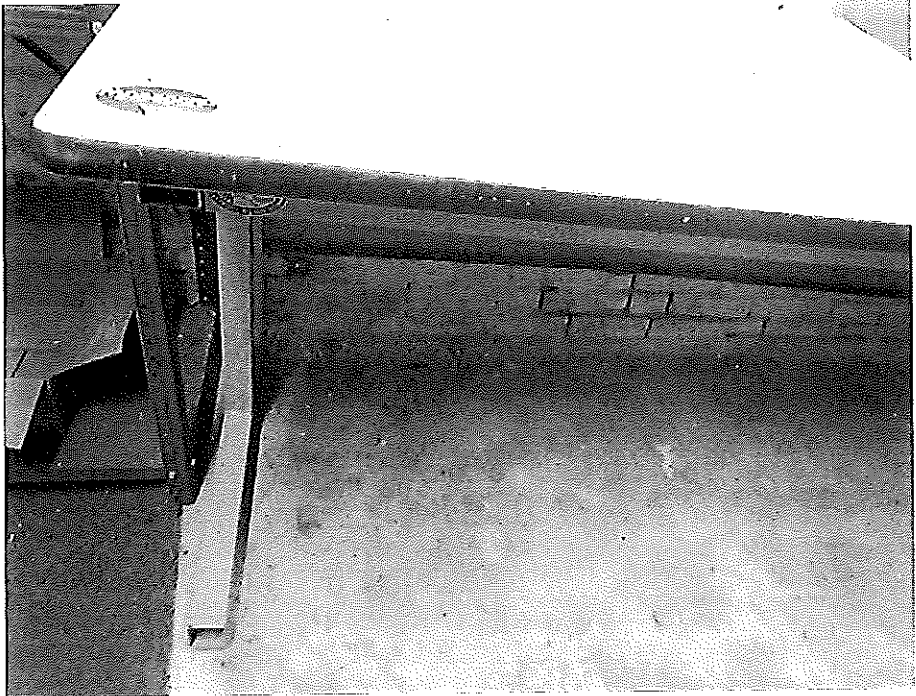
**Picture 21**

**Debris in basement from deterioration of brick**

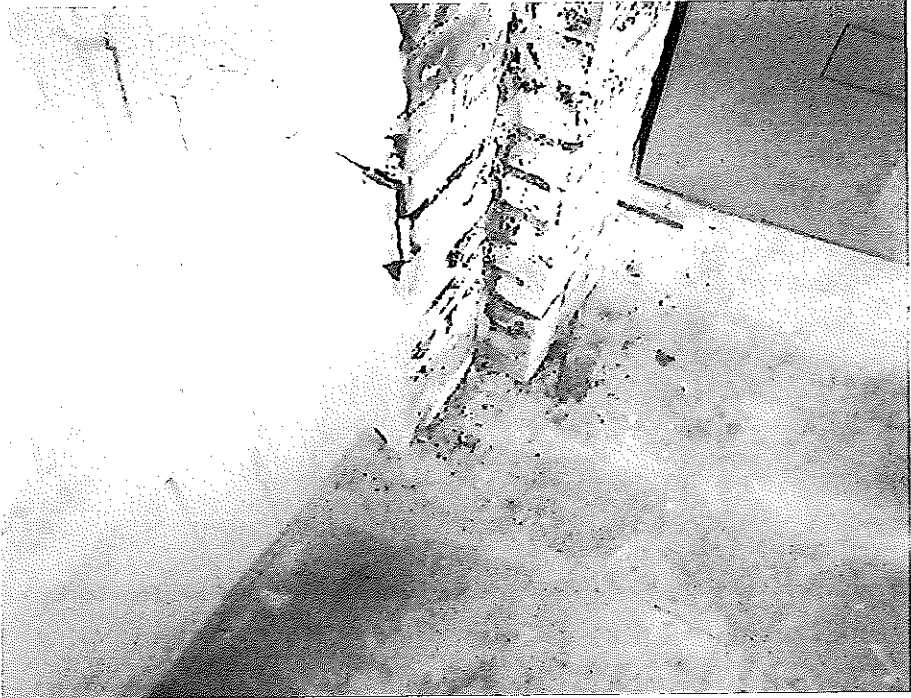
**Picture 22**

**Debris and brick deterioration in the basement**

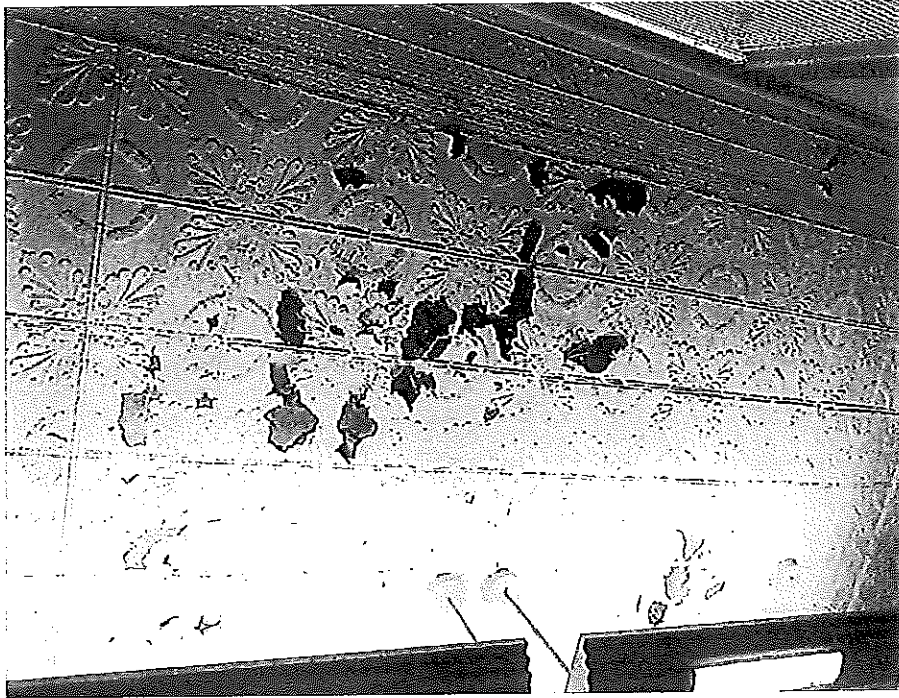
Picture 23

Flaking paint on upper level ceiling

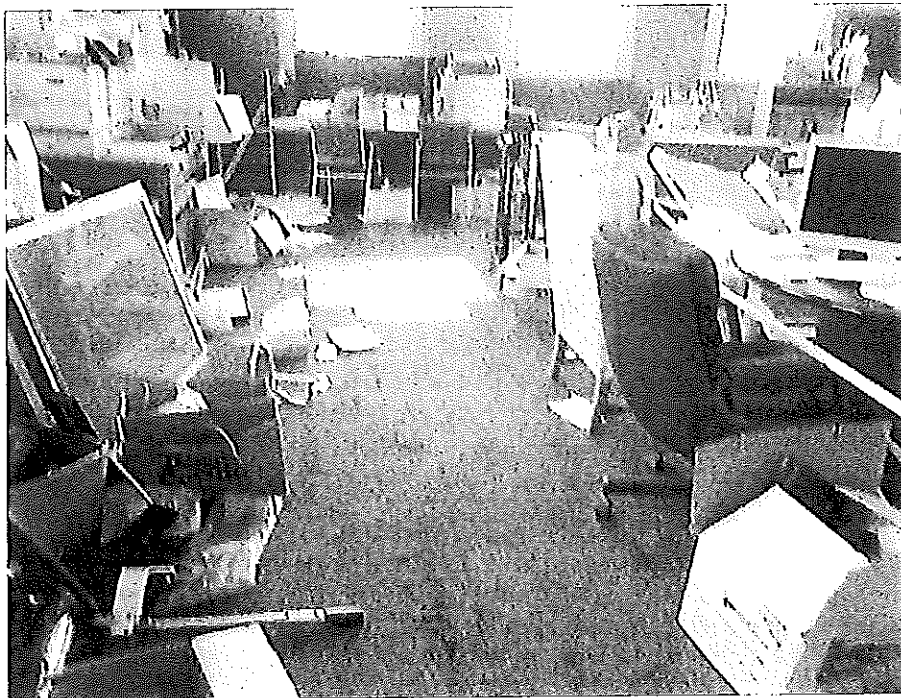
Picture 24

There are a large number of items stored in the PPD, including the upper level and basement (Pictures 24-26). Items should be stored in an organized manner and away from areas with the potential for water damage (e.g., the basement floor) and excessive dust. Items that are

Storage in the upper level

20. Store items in the building neatly and away from any areas with known leaks or water issues. Use totes, shelves, or cabinets to store items neatly and prevent moistening, dust buildup, and pest harborage.

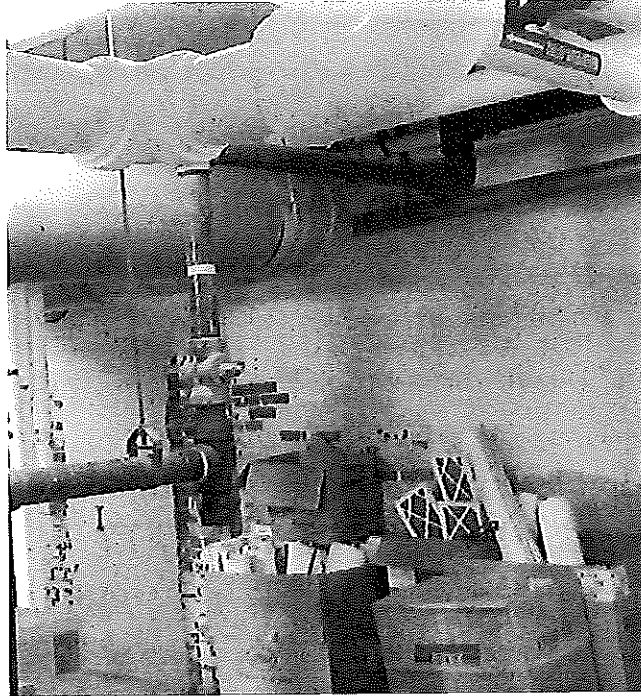
**Picture 25**

**Storage of items in the basement, note filters**

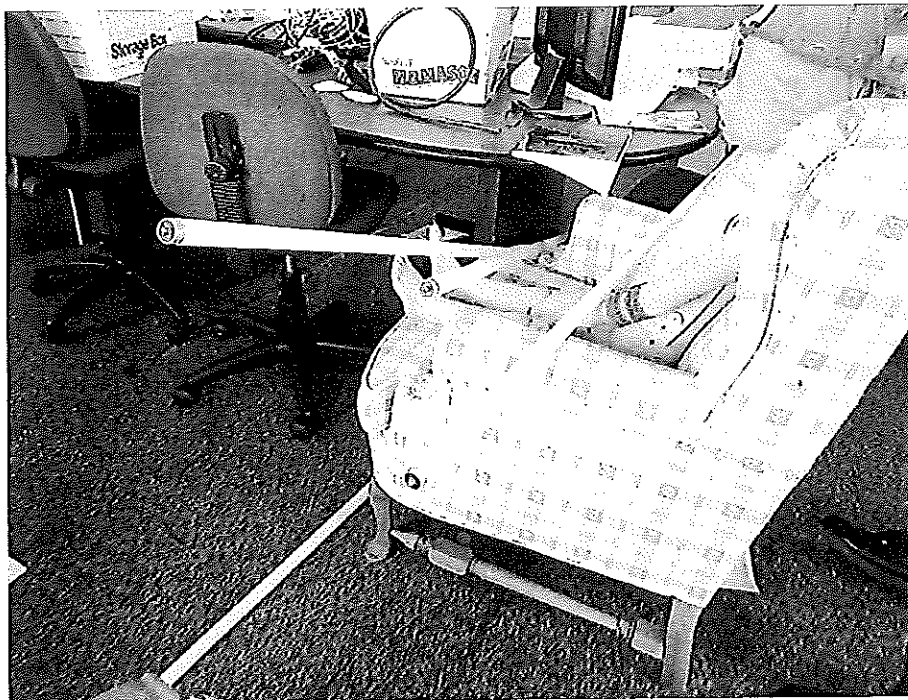
**Picture 26**

not needed or broken should be removed from the building for proper disposal. Special care should be taken with items that are potentially hazardous, including oils, paints, and fluorescent light bulbs (Pictures 24 and 26). If broken, fluorescent bulbs may release mercury. Also note in Picture 25 is a box of the same type of pleated filters used in the FCUs on the first floor. Filters in particular need to be stored in a clean, dry area to avoid contamination with dust, mold and odors which may later be distributed to occupied areas when the filters are used.

**Storage including fluorescent bulbs in the upper level**

21. Store and discard potentially hazardous materials in an appropriate manner to prevent exposure. This includes proper storage and disposal of used fluorescent light bulbs, paint and oils.
